Case 493 : Narrative

Case Vehicle (A): 2003 BMW
Type: 330i, 4-door sedan
Driver: 33-year-old male
CDC: 12-FCEN-3, 05-BYEW-1

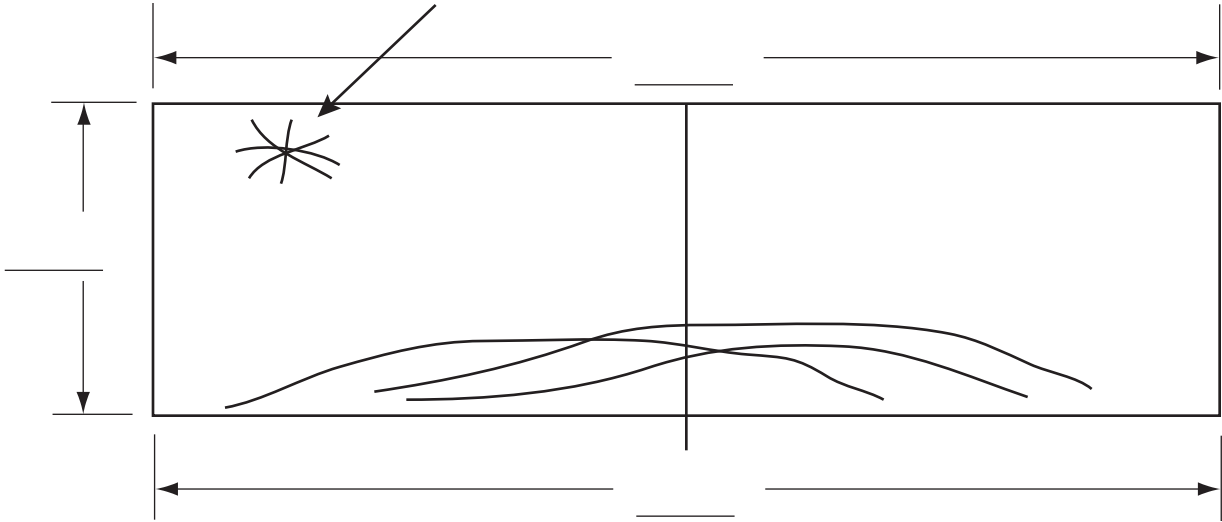
- A: center section knee bolster, scuff**
- B: left section knee bolster, scuff**
- C: windshield, crack**
- D: airbag, blood**
- E: glove box, scuff**
- F: A-pillar, scuff**

driver hand contact
